BLM Cedar City Field Office Site Inspection Report

To: Case file UTU-71326
Dave Penney,
Sliver #1-4 Picasso Marble Mines

Subject: North Pit Site Inspection

Reclamation Treatments Map

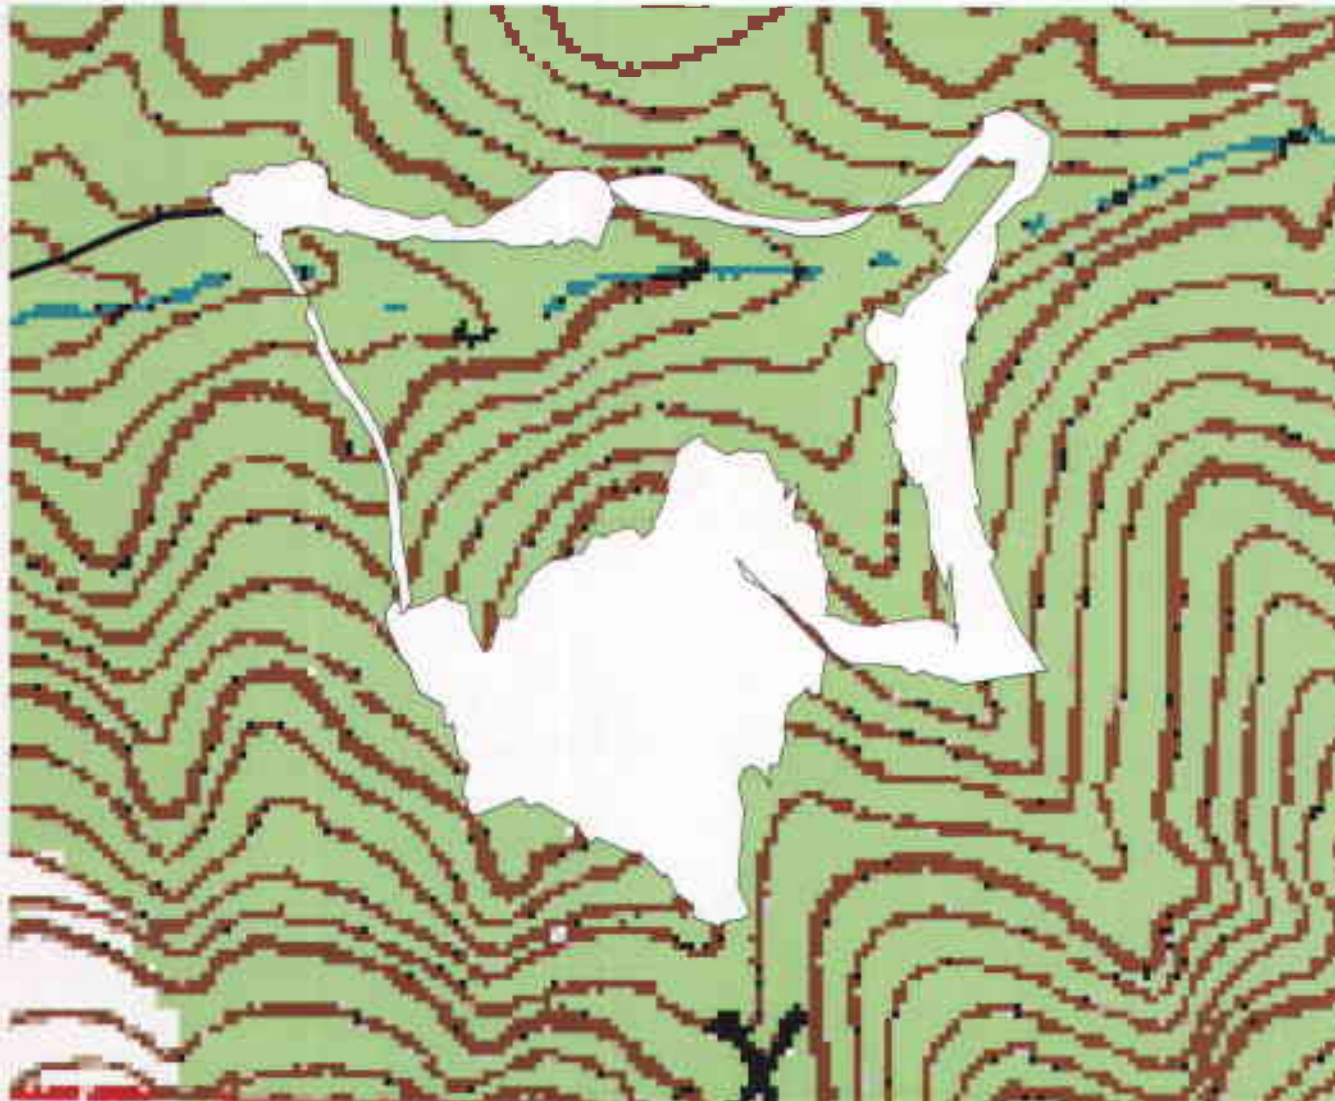
Access Road - .73 acres

Mine Disturbance Area- 4.74 Acres

Inspection performed by Ed Ginouves of the BLM on July 9, 2003.
GPS data to make this map was also collected by Ed Ginouves on July 9, 2003.
